**Flood Control Project Maintenance
Levee Inspections**

Maintenance Issue Types Only, Levee Inspection Report By Mile - Fall 2019

Sacramento River West Side Levee District

Waterway	Bank	Unit Miles	Inspection Start/End	Inspector
Unit No. 01 Sacramento River	Right	49.64	10/22/2019 10/22/2019	Zach Jojola

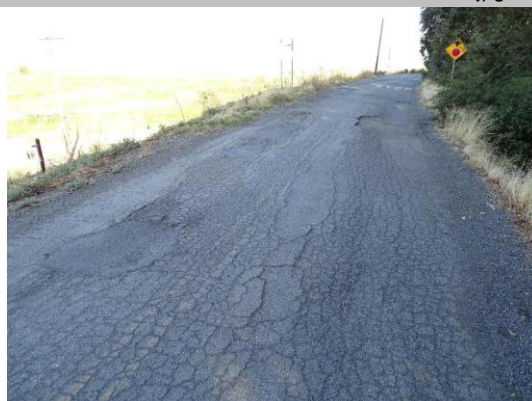
Photo 1 of 3 : UCIP_FA_2019_55792_82912.jpg

Comment Code						
Inspector Comment						
DS_ID:20356 FS_ID:55792 EP_NO: N/A Repair Type: Urgent Crossing Status: Found UCIP Comments: 09/30/2019 Erosion around headwall on WS progresses. Roger Cornwell who is a head of an irrigation district that operates the plant has been notified. Needs to run pumps to see if erosion is caused by leaking pipe(s). (O.Yakimov - DWR UCIP)03/12/2013 Headwall undermined 3-4-feet on WS toe. FIELD_STRUCT_DESC: 2 of 3: 36-inch steel drainage pipe through the levee, 30 feet below the crown. Flap gate on the waterside (WS) end. 24-inch pipe sleeved through the 36-inch pipe. Annular space between pipes grouted. Pumps inside pump house with a walkway on the landside (LS) toe. [Additional Reference(s): DWR Levee Log, 2006. USACE Sacramento O&M Manual 130, May 1960 (HLM 0.15)]. FS Date: 9/30/2019 8:01:37 AM

View of levee crown at the crossing

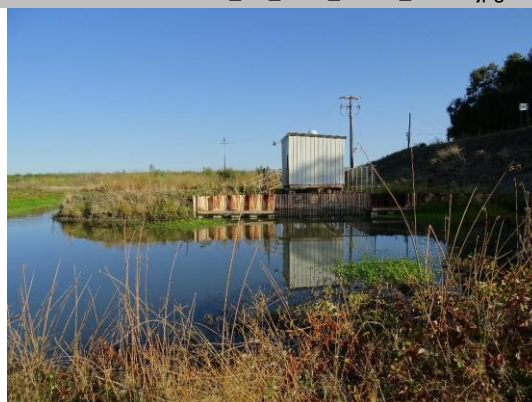
Photo 2 of 3 : UCIP_FA_2019_55792_82911.jpg

Pumping plant on LS

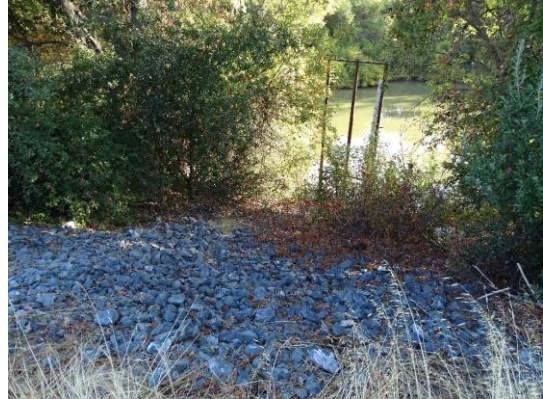
Photo 3 of 3 : UCIP_FA_2019_55792_82916.jpg

Comment Code						
Inspector Comment						
DS_ID:20356 FS_ID:55792 EP_NO: N/A Repair Type: Urgent Crossing Status: Found UCIP Comments: 09/30/2019 Erosion around headwall on WS progresses. Roger Cornwell who is a head of an irrigation district that operates the plant has been notified. Needs to run pumps to see if erosion is caused by leaking pipe(s). (O.Yakimov - DWR UCIP)03/12/2013 Headwall undermined 3-4-feet on WS toe. FIELD_STRUCT_DESC: 2 of 3: 36-inch steel drainage pipe through the levee, 30 feet below the crown. Flap gate on the waterside (WS) end. 24-inch pipe sleeved through the 36-inch pipe. Annular space between pipes grouted. Pumps inside pump house with a walkway on the landside (LS) toe. [Additional Reference(s): DWR Levee Log, 2006. USACE Sacramento O&M Manual 130, May 1960 (HLM 0.15)]. FS Date: 9/30/2019 8:01:37 AM

WS levee slope and air vents

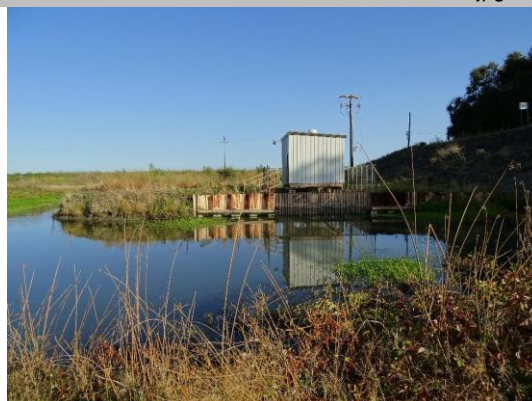
Photo 1 of 3 : UCIP_FA_2019_55793_82917.jpg

Comment Code						
Inspector Comment						
DS_ID:20357 FS_ID:55793 EP_NO: N/A Repair Type: Urgent Crossing Status: Found UCIP Comments: 09/30/2019 Erosion around headwall on WS progresses. Roger Cornwell who is a head of an irrigation district that operates the plant has been notified. Needs to run pumps to see if erosion is caused by leaking pipe(s). (O.Yakimov - DWR UCIP)03/12/2013 Headwall undermined 3-4-feet on WS toe. FIELD_STRUCT_DESC: 3 of 3: 36-inch steel drainage pipe through the levee, 30 feet below the crown. Flap gate on the waterside (WS) end. 24-inch pipe sleeved through the 36-inch pipe. Annular space between pipes grouted. Pumps inside pump house with a walkway on the landside (LS) toe. [Additional Reference(s): DWR Levee Log, 2006. USACE Sacramento O&M Manual 130, May 1960 (HLM 0.15)]. FS Date: 9/30/2019 8:02:02 AM

Pump house on LS

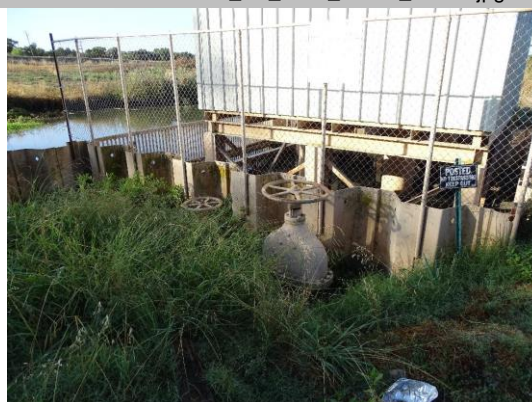
Photo 2 of 3 : UCIP_FA_2019_55793_82920.jpg

Slide gates at pumphouse on LS toe

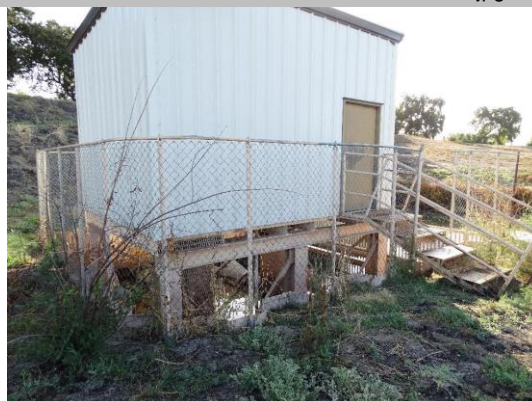
Photo 3 of 3 : UCIP_FA_2019_55793_82921.jpg

Pump house view from LS looking towards levee

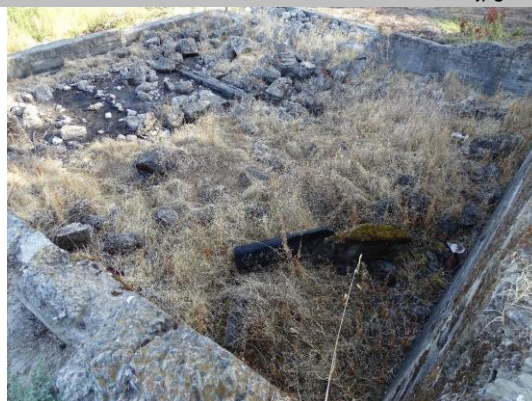
Photo 1 of 2 : UCIP_FA_2019_55794_82922.jpg

LM Start	0.22	Rating **	M	Issue No.	1555
LM End	0.22	Issue Type +	Ma	Location *	
Category	Supplemental			GPS Latitude/Longitude	
				Start	End
Item	DRAFT DWR UCIP LMA Responsibility			38.802293 °	38.802293 °
				-121.724847 °	-121.724847 °
DWR ID	20327				
Comment Code					
Inspector Comment					
DS_ID:20327					
FS_ID:55794					
EP_NO: N/A					
Repair Type: Non-Urgent					
Crossing Status: Found					
UCIP Comments: 09/30/2019 Crossing looks abandoned (O.Yakimov - DWR UCIP)					
FIELD_STRUCT_DESC: *ABANDONED* 42-inch drainage pipe of an unknown material through the levee, 28.5 feet below the crown.					
Abandoned in place by plugging with concrete. Headwall on waterside (WS) toe. [Additional Reference(s): USACE Sacramento O&M Manual 130, May 1960 (HLM 0.22)].					
FS Date: 9/30/2019 9:45:45 AM

Ruins of a structure on LS

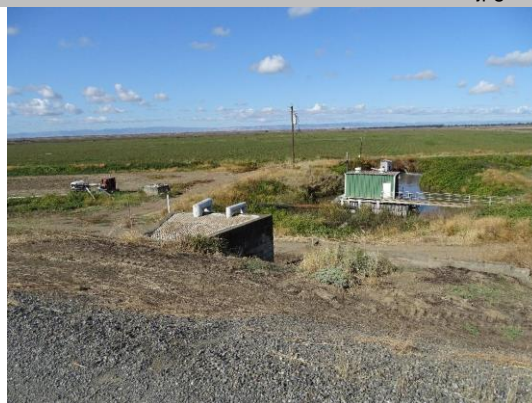
Photo 1 of 3 : UCIP_FA_2019_55802_82942.jpg

View of LS looking from levee crown

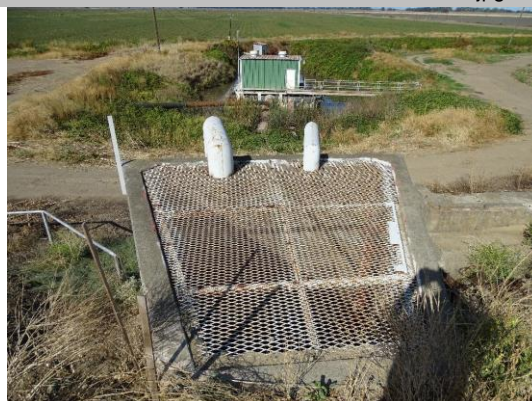
Photo 2 of 3 : UCIP_FA_2019_55802_82944.jpg

Top of concrete distribution box. Two filling pipes are coming from pump house.

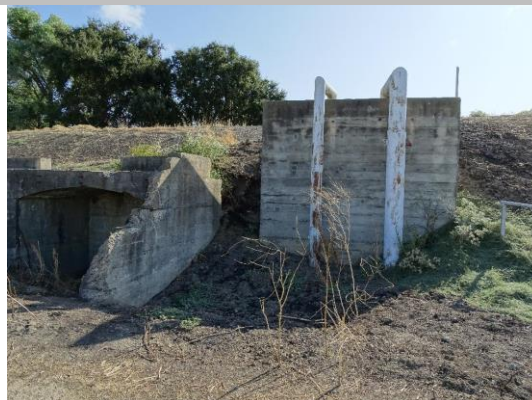
Photo 3 of 3 : UCIP_FA_2019_55802_82943.jpg

Concrete distribution box on LS slope

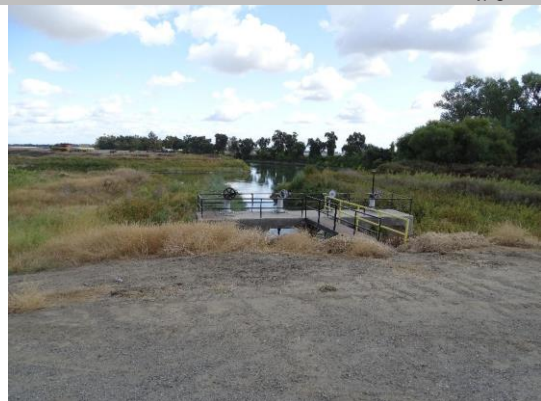
Photo 2 of 3 : UCIP_FA_2019_55837_83075.jpg

Walkway to slide gate actuators on WS shoulder

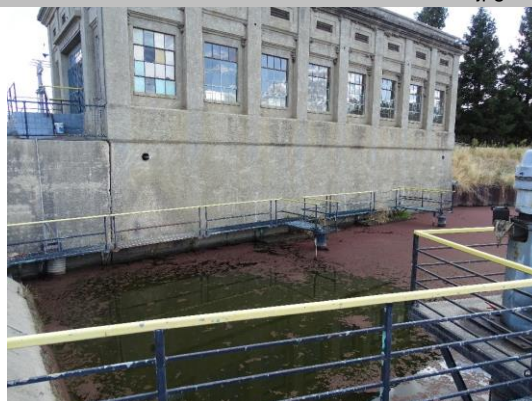
Photo 3 of 3 : UCIP_FA_2019_55837_83096.jpg

LS view of pumping plant looking from irrigation canal

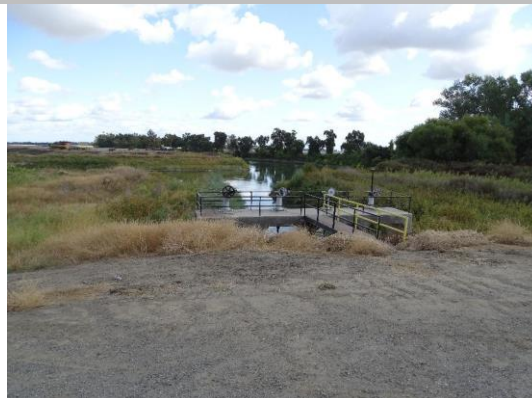
Photo 1 of 3 : UCIP_FA_2019_55838_83077.jpg

Walkway to slide gate actuators on WS shoulder

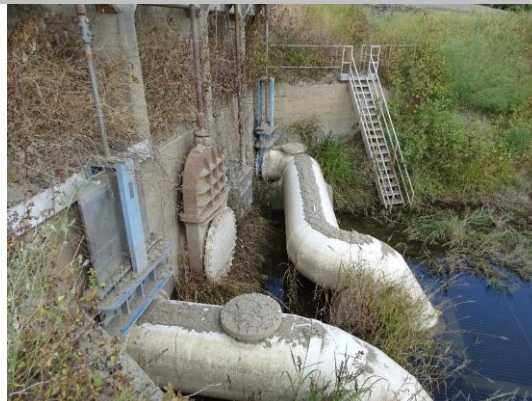
Photo 2 of 3 : UCIP_FA_2019_55838_83078.jpg

Pipes and slide gates at outlet onWS

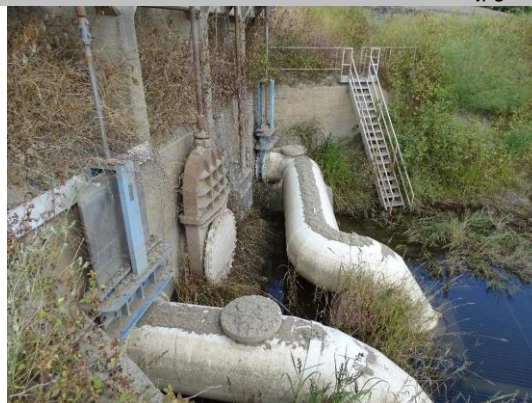
Photo 2 of 3 : UCIP_FA_2019_55839_83080.jpg

Pipes and slide gates at outlet on WS

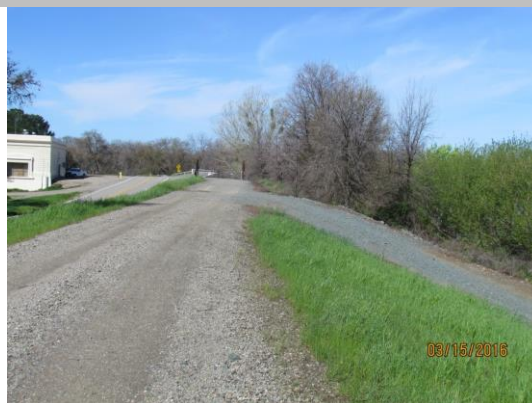
Photo 1 of 2 : FA_2019_NA0016_435_29_20190829_00007.jpg

LM Start	9.68	Rating **	A/W	Issue No.	29
LM End	9.79	Issue Type +	Ma	Location *	WS
Category	Earthen Levee			GPS Latitude/Longitude	
				Start	End
Item	Vegetation			38.862345 °	38.862848 °
				-121.791337 °	-121.793267 °
DWR ID	DWR_NA0016_01_s_2012_29				
Comment Code					
V8 : Environmental Requirements.					
Inspector Comment

View of the revegetation site on the waterward side of the levee looking upstream. Spring 2016.

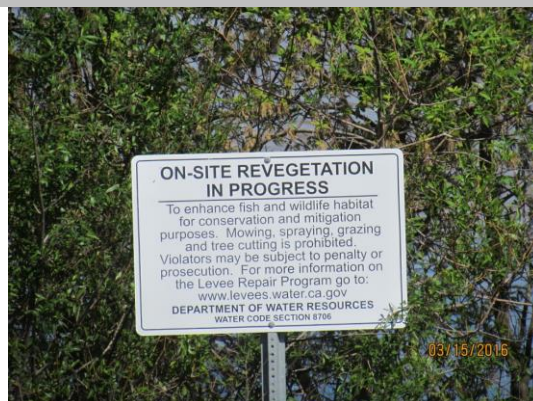
Photo 2 of 2 : FA_2019_NA0016_435_29_20190829_00008.jpg

Revegetation site sign. Spring 2016.

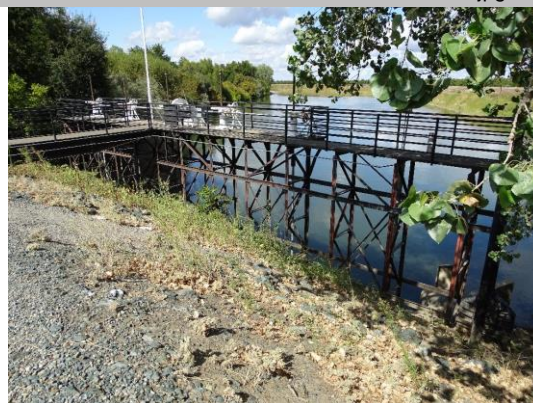
Photo 1 of 3 : UCIP_FA_2019_55842_83088.jpg

Slide gate actuators on WS shoulder

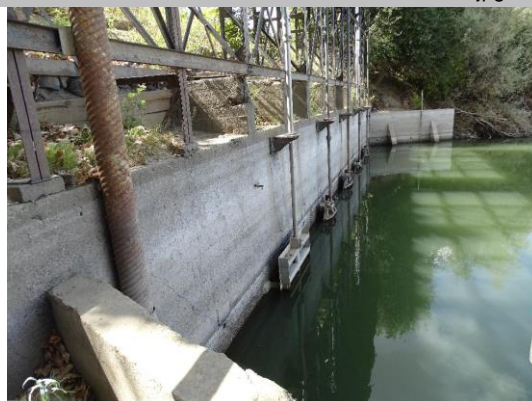
Photo 2 of 3 : UCIP_FA_2019_55842_83097.jpg

Slide gates at concrete headwall at river

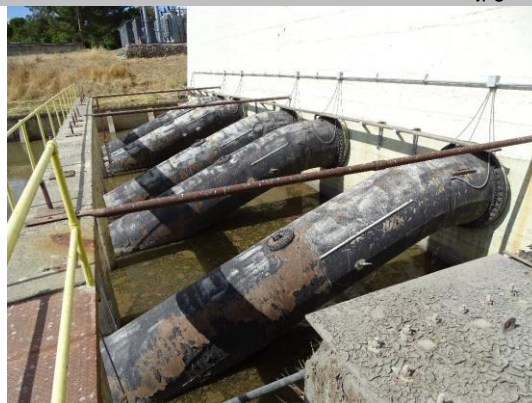
Photo 3 of 3 : UCIP_FA_2019_55842_83098.jpg

Pipes at entrance to pumping plant building on LS toe

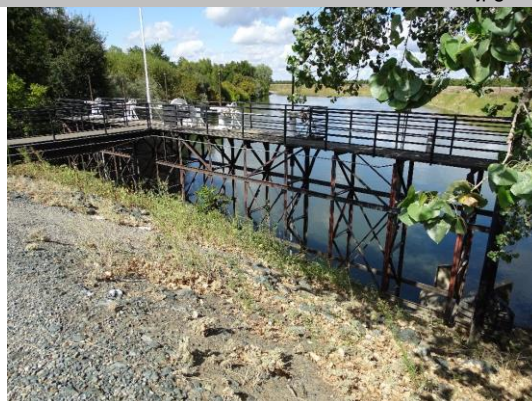
Photo 1 of 3 : UCIP_FA_2019_55843_83099.jpg

Slide gate actuators on WS shoulder

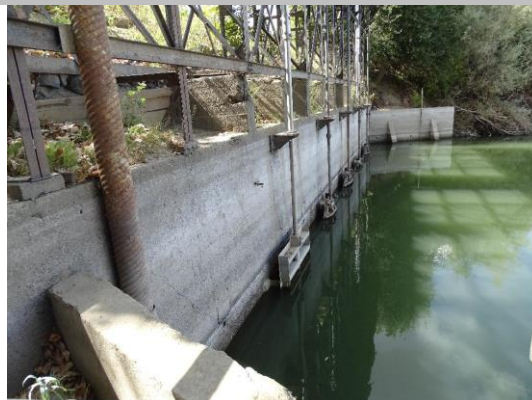
Photo 2 of 3 : UCIP_FA_2019_55843_83100.jpg

Slide gates at concrete headwall at river

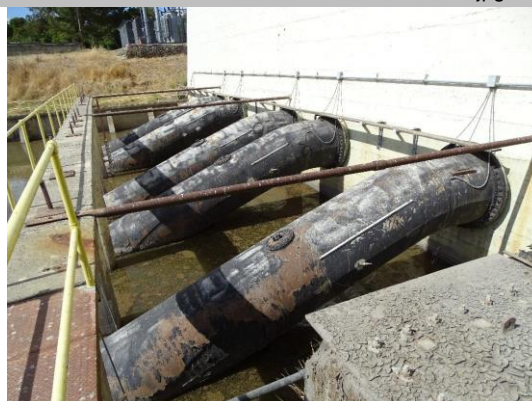
Photo 3 of 3 : UCIP_FA_2019_55843_83101.jpg

Pipes at entrance to pumping plant building on LS toe

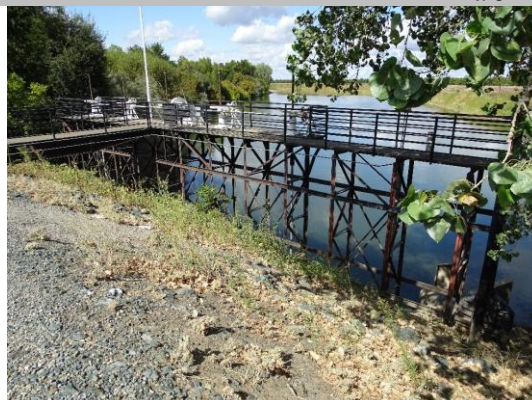
Photo 1 of 3 : UCIP_FA_2019_55844_83102.jpg

Comment Code					
Inspector Comment					
DS_ID:20365					
FS_ID:55844					
EP_NO: N/A					
Repair Type: Non-Urgent					
Crossing Status: Found					
UCIP Comments: 09/30/2019 No issues recorded during inspection (O.Yakimov - DWR UCIP)					
FIELD_STRUCT_DESC: 3 of 5: 60-inch reinforced concrete drainage culvert through the levee, 35 feet below the crown. Screw gate actuators on metal platform on the waterside (WS) shoulder. Large pumping plant building on the landside (LS) shoulder. Staff gauge to 47 feet on structure. [Additional Reference(s): DWR Levee Log, 2006. USACE Sacramento O&M Manual 130, May 1960 (HLM 9.87)].					
FS Date: 9/30/2019 11:48:05 AM

Slide gate actuators on WS shoulder

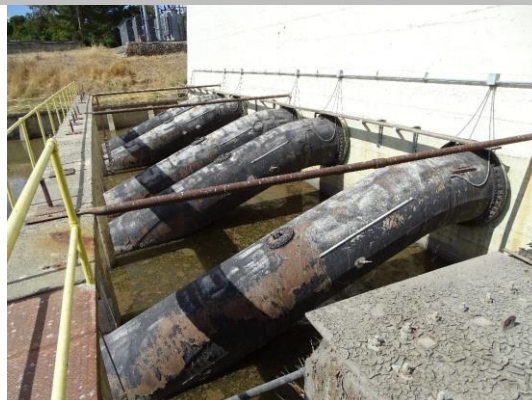
Photo 3 of 3 : UCIP_FA_2019_55844_83104.jpg

Pipes at entrance to pumping plant building on LS toe

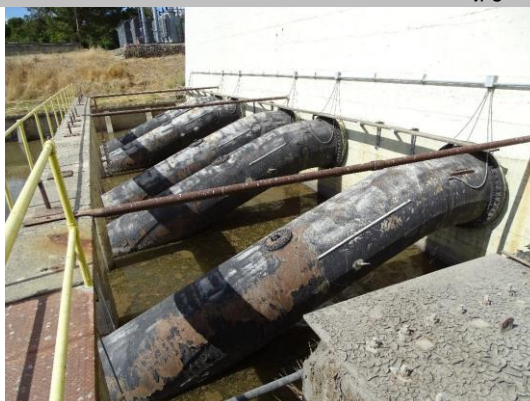
Photo 3 of 3 : UCIP_FA_2019_55845_83107.jpg

Comment Code						
Inspector Comment						
DS_ID:20366						
FS_ID:55845						
EP_NO: N/A						
Repair Type: Non-Urgent						
Crossing Status: Found						
UCIP Comments: 09/30/2019 No issues recorded during inspection (O.Yakimov - DWR UCIP)						
FIELD_STRUCT_DESC: 4 of 5: 60-inch reinforced concrete drainage culvert through the levee, 35 feet below the crown. Screw gate actuators on metal platform on the waterside (WS) shoulder. Large pumping plant building on the landside (LS) shoulder. Staff gauge to 47 feet on structure. [Additional Reference(s): DWR Levee Log, 2006. USACE Sacramento O&M Manual 130, May 1960 (HLM 9.87)].						
FS Date: 9/30/2019 11:48:29 AM

Pipes at entrance to pumping plant building on LS toe

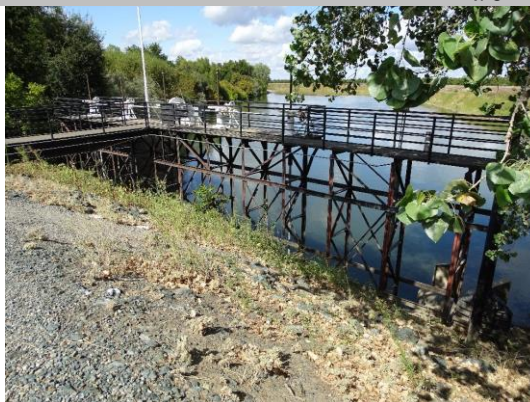
Photo 1 of 3 : UCIP_FA_2019_55846_83108.jpg

Comment Code					
Inspector Comment					
DS_ID:20367					
FS_ID:55846					
EP_NO: N/A					
Repair Type: Non-Urgent					
Crossing Status: Found					
UCIP Comments: 09/30/2019 No issues recorded during inspection (O.Yakimov - DWR UCIP)					
FIELD_STRUCT_DESC: 5 of 5: 60-inch reinforced concrete drainage culvert through the levee, 35 feet below the crown. Screw gate actuators on metal platform on the waterside (WS) shoulder. Large pumping plant building on the landside (LS) shoulder. Staff gauge to 47 feet on structure. [Additional Reference(s): DWR Levee Log, 2006. USACE Sacramento O&M Manual 130, May 1960 (HLM 9.87)].					
FS Date: 9/30/2019 11:48:54 AM

Slide gate actuators on WS shoulder

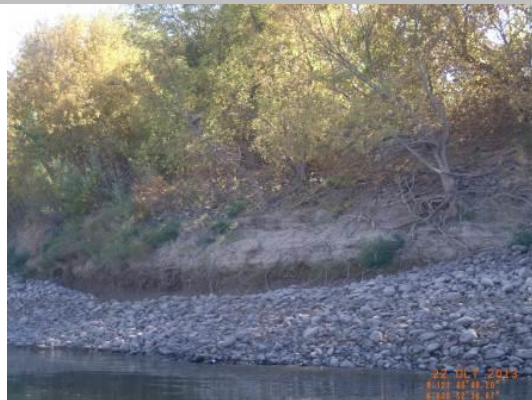
Photo 1 of 1 : FA_2019_NA0016_435_84_20190829_00022.jpg

LM Start	11.50	Rating **	A/W	Issue No.	84
LM End	11.53	Issue Type +	Ma	Location *	WS
Category	Supplemental			GPS Latitude/Longitude	
				Start	End
Item	2017 USACE Erosion Survey			38.874854 °	38.875109 °
				-121.813018 °	-121.813592 °
DWR ID	DWR_NA0016_01_f_2018_84				
Comment Code					
Inspector Comment					
2017 Site ID: SAC 101.3 R					
Status: Eroding					
2017 Field Notes: No observed change..					
Site History: 1997 - Toe damage and loss of cobble revetment and small patch of local damage to the cobble revetment. 2000 - Cohesive vertical toe; revegetation site.

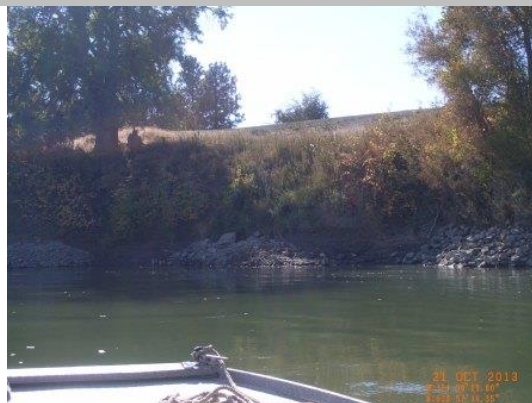
Photo 1 of 1 : FA_2019_NA0016_435_85_20190829_00023.jpg

LM Start	18.76	Rating **	A/W	Issue No.	85
LM End	18.78	Issue Type +	Ma	Location *	WS
Category	Supplemental			GPS Latitude/Longitude	
				Start	End
Item	2017 USACE Erosion Survey			38.954060 °	38.954312 °
				-121.840560 °	-121.840774 °
DWR ID	DWR_NA0016_01_f_2018_85				
Comment Code					
Inspector Comment					
2017 Site ID: SAC 111.0 R					
Status: Eroding					
2017 Field Notes: No observed change.					
Site History: 2009 - Minor erosion, should be repaired under maintenance. 2011 - Some new minor erosion at the toe.

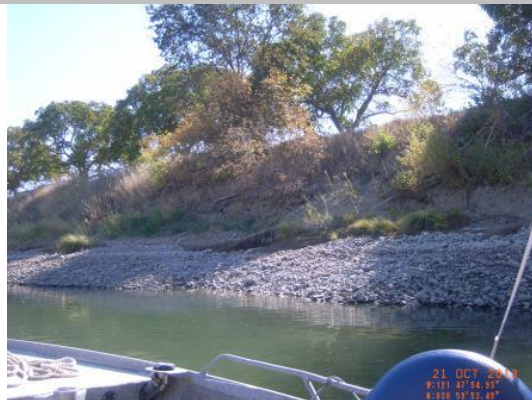
Photo 1 of 1 : FA_2019_NA0016_435_86_20190829_00024.jpg

LM Start	23.55	Rating **	A/W	Issue No.	86
LM End	23.65	Issue Type +	Ma	Location *	WS
Category	Supplemental			GPS Latitude/Longitude	
				Start	End
Item	2017 USACE Erosion Survey			38.997696 °	38.998336 °
				-121.797584 °	-121.799298 °
DWR ID	DWR_NA0016_01_f_2018_86				
Comment Code					
Inspector Comment					
2017 Site ID: SAC 115.9 R					
Status: Eroding					
2017 Field Notes: No observed change.					
Site History: 2008 - Slippage of cobbles off hard underlying toe material. 2011 - Minor slumping site. 2012 - Failing cobble site, site extended upstream. 2016 - New erosion pockets.

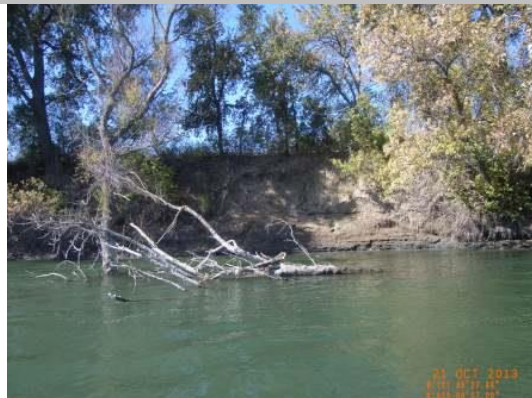
Photo 1 of 1 : FA_2019_NA0016_435_88_20190829_00026.jpg

LM Start	25.75	Rating **	A/W	Issue No.	88
LM End	25.91	Issue Type +	Ma	Location *	WS
Category	Supplemental			GPS Latitude/Longitude	
				Start	End
Item	2017 USACE Erosion Survey			39.014499 °	39.016401 °
				-121.825880 °	-121.824230 °
DWR ID	DWR_NA0016_01_f_2018_88				
Comment Code					
Inspector Comment					
2017 Site ID: SAC 118.0 R					
Status: Eroding					
2017 Field Notes: No observed change.					
Site History: 2008 - Whole bank is eroding, nearly vertical slope with cohesive toe. Bed is very deep along the toe (greater than 30 ft deep at 20 ft from the shore). 2011 - Some new minor erosion. 2016 - Minor new erosion.

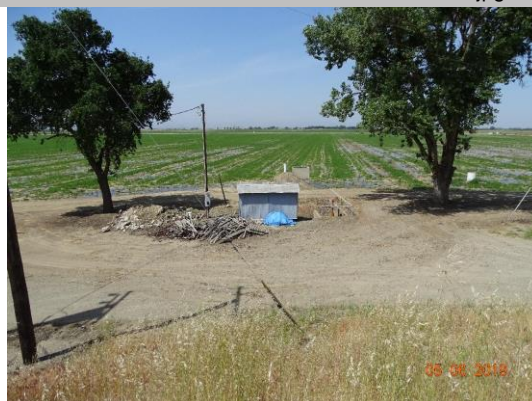
Photo 1 of 3 : UCIP_FA_2019_53985_79218.jpg

Comment Code					
Inspector Comment					
DS_ID:20341 FS_ID:53985 EP_NO: 9358 Repair Type: Non-Urgent Crossing Status: Found UCIP Comments: 05/06/2019 No issues recorded during inspection. (O.Yakimov - DWR UCIP) FIELD_STRUCT_DESC: 16-inch steel drainage pipe through the levee, 8.5 feet below the crown. Siphon breaker inside a 24-inch corrugated metal riser unit on the waterside (WS) slope. Pump inside pump house on the landside (LS). Overhead power line crosses the levee. Pole on the LS shoulder. (one 12-inch, one 16-inch, and one 24-inch pipes [HLM 29.02] authorized under Automatic Board Order (ABO) issued as Permit No. 9358, 1974 - Crocker National Bank (Trustee)). [Additional Reference(s): DWR Levee Log, 2006. USACE Sacramento O&M Manual 131, May 1960 (HLM 29.02)]. FS Date: 5/6/2019 12:51:38 PM

Pumphouse and sump on LS looking from levee crown

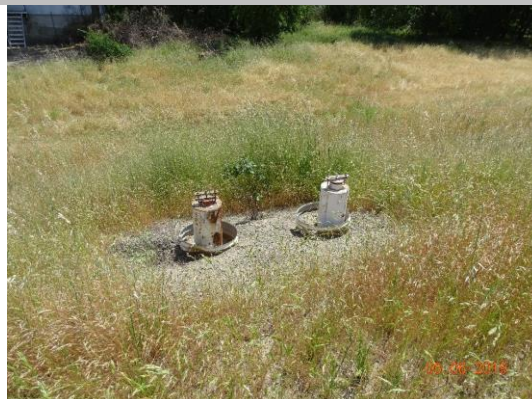
Photo 2 of 3 : UCIP_FA_2019_53985_79217.jpg

CMP riser with siphon breaker on WS slope

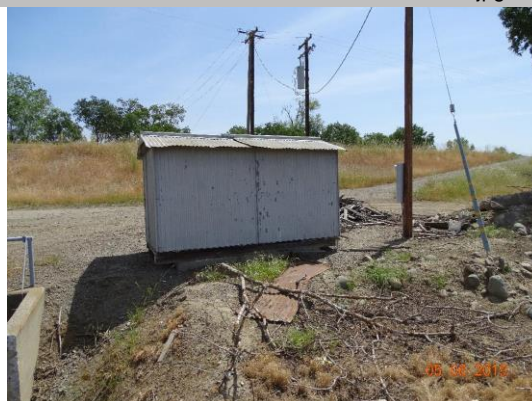
Photo 3 of 3 : UCIP_FA_2019_53985_79219.jpg

Pumphouse and sump on LS looking from landside

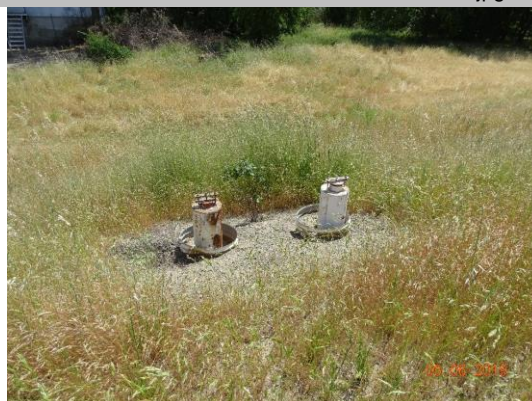
Photo 1 of 3 : UCIP_FA_2019_53986_79220.jpg

Comment Code					
Inspector Comment					
DS_ID:20259 FS_ID:53986 EP_NO: 9358 Repair Type: Non-Urgent Crossing Status: Found UCIP Comments: 05/06/2019 No issues recorded during inspection. (O.Yakimov - DWR UCIP) FIELD_STRUCT_DESC: 10-inch steel drainage pipe through the levee, 8 feet below the crown. Siphon breaker in a 24-inch corrugated metal riser on the waterside (WS) slope. Slide gate at base of pump house on landside (LS) toe. Pump over sump at pump house on LS toe. Overhead power line crosses the levee. Pole on the LS shoulder. (one 12-inch, one 16-inch, and one 24-inch pipes [HLM 29.02] authorized under Automatic Board Order (ABO) issued as Permit No. 9358, 1974 - Crocker National Bank (Trustee)). [Additional Reference(s): DWR Levee Log, 2006. USACE Sacramento O&M Manual 131, May 1960 (HLM 29.02)]. FS Date: 5/6/2019 2:23:55 PM

CMP riser with siphon breaker on WS slope

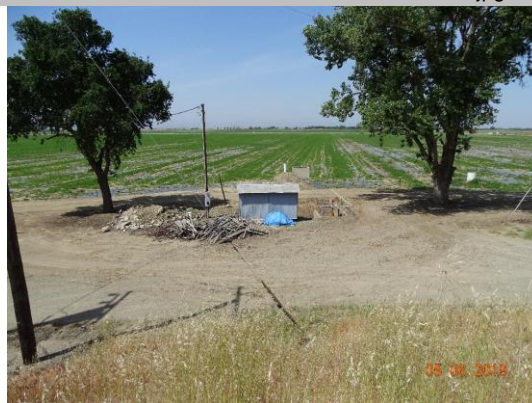
Photo 2 of 3 : UCIP_FA_2019_53986_79221.jpg

Pumphouse and sump on LS looking from levee crown

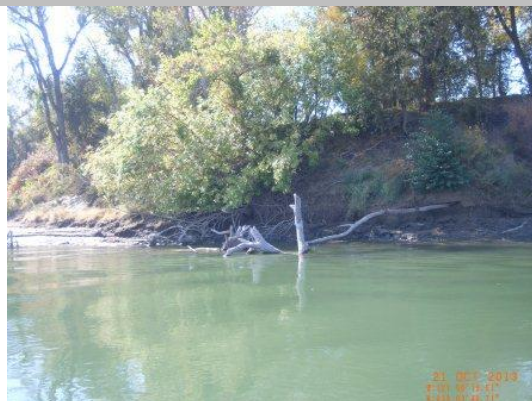
Photo 1 of 1 : FA_2019_NA0016_435_89_20190829_00027.jpg

LM Start	29.69	Rating **	A/W	Issue No.	89
LM End	29.73	Issue Type +	Ma	Location *	WS
Category	Supplemental			GPS Latitude/Longitude	
				Start	End
Item	2017 USACE Erosion Survey			39.063209 °	39.063997 °
				-121.838927 °	-121.839335 °
DWR ID	DWR_NA0016_01_f _ 2018_89				
Comment Code					
Inspector Comment					
2017 Site ID: SAC 122.0 R					
Status: Eroding					
2017 Field Notes: Minor new erosion at toe.					
Site History: 1997 - Mass failure of the lower cohesive bank and toe.					
2000 - Still eroding, steeply dipping foresets in the toe are falling off.					
2010 - Some new erosion and some new deposition. Eddy current off					
the upstream rock. 2011 - Still plenty of berm left. 2016 - Minor new					
erosion.

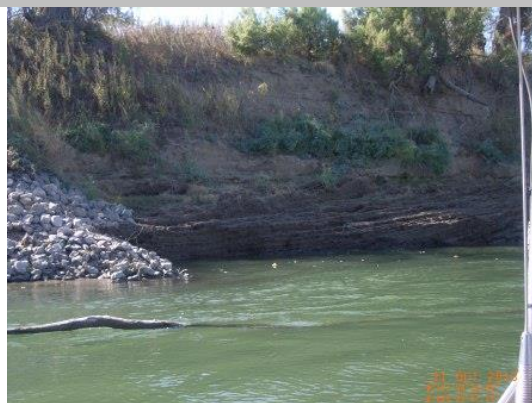
Photo 1 of 1 : FA_2019_NA0016_435_91_20190829_00029.jpg

Comment Code					
Inspector Comment					
2017 Site ID: SAC 122.3 R					
Status: Eroding					
2017 Field Notes: Fresh slumping erosion at toe.					
Site History: 2002 - Upstream end has recent slope failure and exposure of tree roots. 2003 - Some new minor slope erosion with new snags on the bank. 2004 - Appears a little worse. 2005 - Scallop in bank at the upstream end looks worse. 2009 - Minimal new erosion, Berm width is still large, but one large event or one fallen tree and it could go fast. 2010 - New erosion, bank is nearly all vertical from slumping. Site looks bad. 2011 - Site continues to look bad. 2012 - Minor new erosion. 2015 - Undermining of toe rock. 2016 - Site extended upstream, new erosion and exposed tree roots.

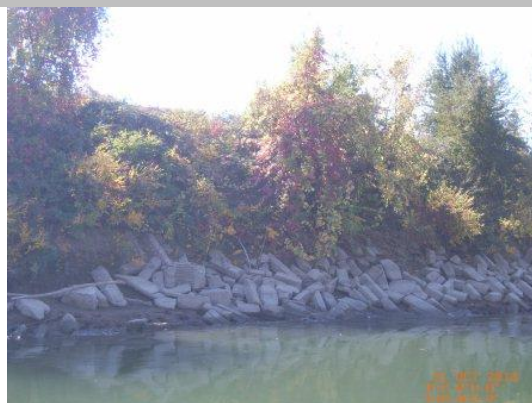
Photo 1 of 1 : FA_2019_NA0016_435_92_20190829_00030.jpg

LM Start	31.43	Rating **	A/W	Issue No.	92
LM End	31.45	Issue Type +	Ma	Location *	WS
Category	Supplemental			GPS Latitude/Longitude	
				Start	End
Item	2017 USACE Erosion Survey			39.067004°	39.066901°
				-121.866913°	-121.867322°
DWR ID	DWR_NA0016_01_f_2018_92				
Comment Code					
Inspector Comment					
2017 Site ID: SAC 123.7 R					
Status: Eroding					
2017 Field Notes: No observed change.					
Site History: 1997 - Erosion into the levee section; old concrete rubble loss at toe; transition between the rock upstream and the cobble downstream. 2000 - Cohesive bench with concrete slabs on top; 25 ft deep scour hole on the downstream end.

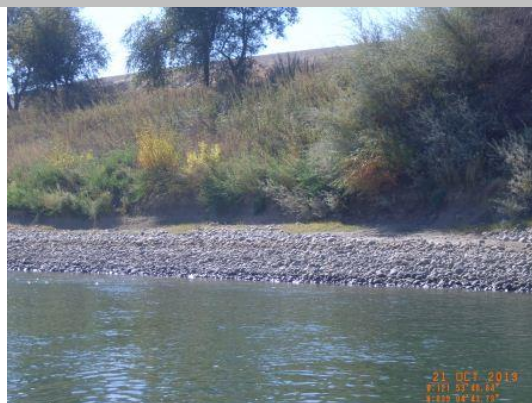
Photo 1 of 1 : FA_2019_NA0016_435_93_20190829_00031.jpg

LM Start	33.29	Rating **	A/W	Issue No.	93
LM End	33.37	Issue Type +	Ma	Location *	WS
Category	Supplemental			GPS Latitude/Longitude	
				Start	End
Item	2017 USACE Erosion Survey			39.078340 °	39.079351 °
				-121.894656 °	-121.895317 °
DWR ID	DWR_NA0016_01_f_2018_93				
Comment Code					
Inspector Comment					
2017 Site ID: SAC 125.6 R					
Status: Eroding					
2017 Field Notes: No observed change.					
Site History: 2008 - Slow erosion of the hard toe. 2010 - Cobble rubble is failing, erosion is into the toe of the levee, with vertical slumping.					
2012 - Site appears to be relatively stable. 2013 - New animal holes.

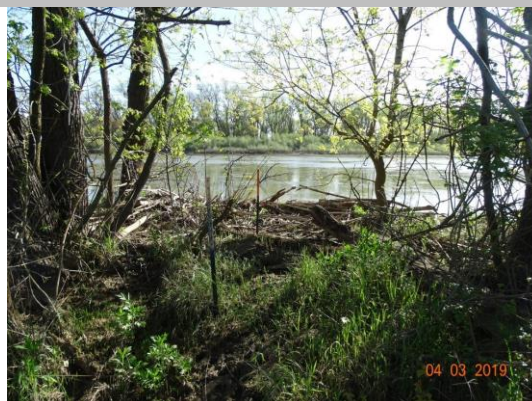
Photo 2 of 5 : FA_2019_NA0016_435_114_20190829_00049.jpg

LM Start	35.26	Rating **	A/W	Issue No.	114 (cont)	
LM End	35.29	Issue Type +	Ma	Location *	WS	
Category	Earthen Levee			GPS Latitude/Longitude		
				Start		End
Item	Erosion / Bank Caving			39.099746 °	39.100122 °	
				-121.904555 °	-121.904658 °	
DWR ID	DWR_NA0016_01_s_2019_114					
Comment Code						
E1 : Note and monitor erosion site.						
Inspector Comment						
Erosion on the waterside berm reported during 2018 storms. Approximately 45' from the bank to the waterside toe is left. Recommend monitoring.

View of the middle stake on the waterside berm. Spring 2019.

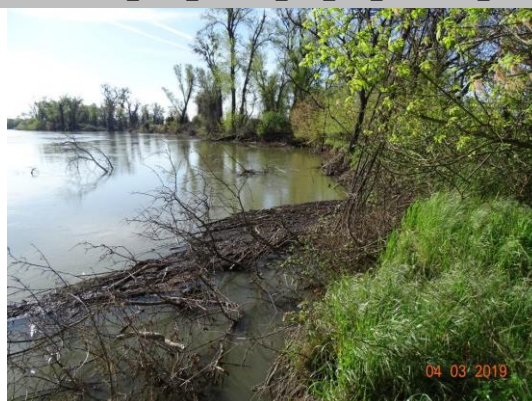
Photo 3 of 5 : FA_2019_NA0016_435_114_20190829_00050.jpg

View of the erosion site facing downstream. Spring 2019.

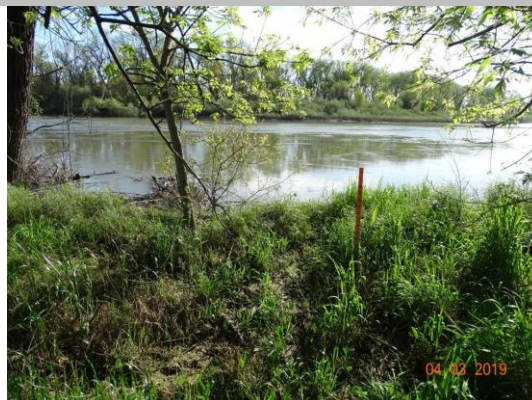
Photo 4 of 5 : FA_2019_NA0016_435_114_20190829_00051.jpg

View of the upstream stake on the waterside berm. Spring 2019.

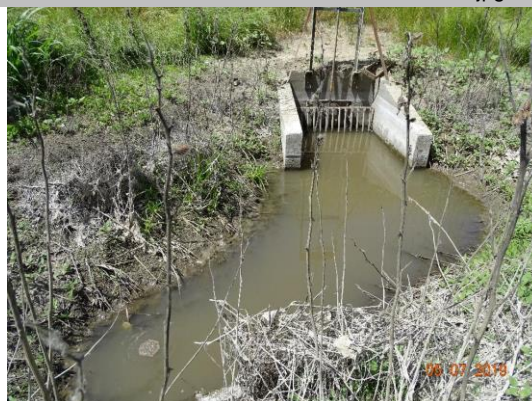
Photo 1 of 3 : UCIP_FA_2019_54164_79775.jpg

Comment Code						
Inspector Comment						
DS_ID:20345						
FS_ID:54164						
EP_NO: 9374						
Repair Type: Non-Urgent						
Crossing Status: Found						
UCIP Comments: 05/07/2019 Pipe is capped on LS approximately 15 feet from LS toe. Minor water leakage observed around capped pipe. (O.Yakimov - DWR UCIP)03/18/2013 Verify if pipe is abandoned with landowner and remove or abandon properly if necessary.						
FIELD_STRUCT_DESC: *ABANDONED* 3 of 3: 24-inch concrete encased steel drainage pipe through the levee, 17 feet below the crown. Slide gate on concrete headwall on waterside (WS) end. Walkway to control gate and gate valve on landside (LS) end. (24-inch pipe [HLM 36.61] authorized under Automatic Board Order (ABO) issued as Permit No. 9374, 1974 - Richard H. Moore). [Additional Reference(s): USACE Sacramento O&M Manual 131, May 1960 (HLM 36.61)].						
FS Date: 5/7/2019 8:40:51 AM

Outlet/inlet on WS toe

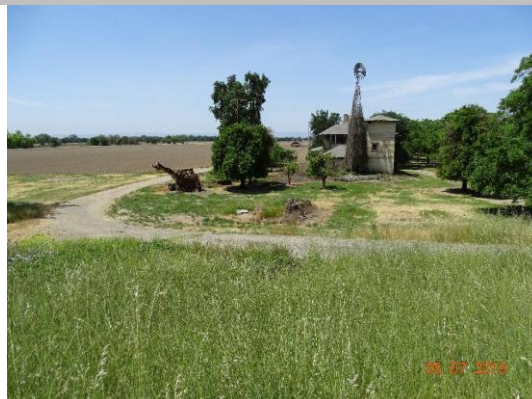
Photo 2 of 3 : UCIP_FA_2019_54164_79776.jpg

LS levee slope

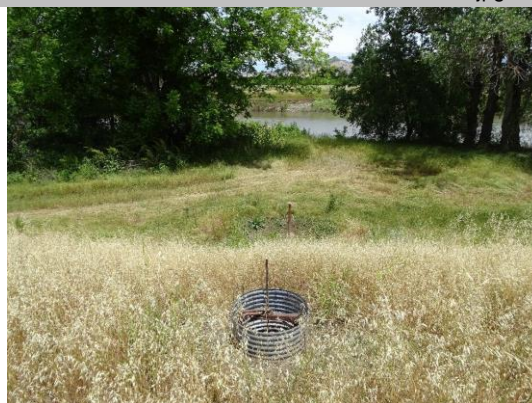
Photo 1 of 3 : UCIP_FA_2019_54216_79906.jpg

Comment Code						
Inspector Comment						
DS_ID:20288 FS_ID:54216 EP_NO: N/A Repair Type: Non-Urgent Crossing Status: Found UCIP Comments: 05/22/2019 CMP riser on WS shoulder missing a cover that creates fall hazard. A new electrical conduit is noticed on WS berm near pipe alignment. (O.Yakimov - DWR UCIP) FIELD_STRUCT_DESC: 24-inch drainage pipe of an unknown material through the levee, 19 feet below the crown. 6-foot diameter corrugated metal standpipe on the landside (LS) toe. Pump and 24-inch pipe on the LS. Slide gate in corrugated metal riser unit on waterside (WS) slope. Concrete block wall at WS toe for discharge line. (Modified under Permit No. 8587, 1973 - Anthony E. Steidlmayer). [Additional Reference(s): DWR Levee Log, 2006. USACE Sacramento O&M Manual 131, May 1960 (HLM 41.56)]. FS Date: 5/22/2019 2:35:19 PM

Corrugated metal riser on WS shoulder

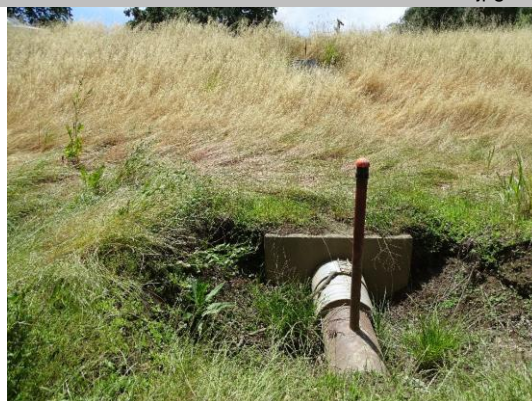
Photo 2 of 3 : UCIP_FA_2019_54216_79904.jpg

Concrete block wall at WS toe

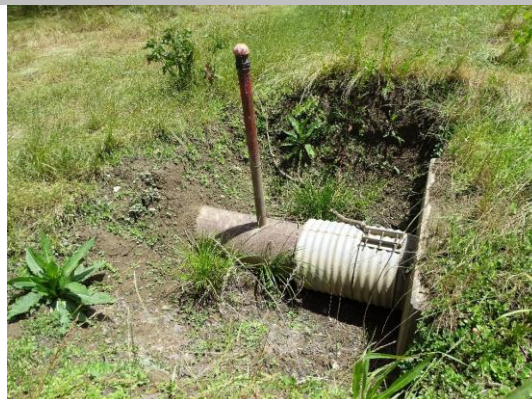
Photo 3 of 3 : UCIP_FA_2019_54216_79903.jpg

Siphon breaker on pipe at WS toe

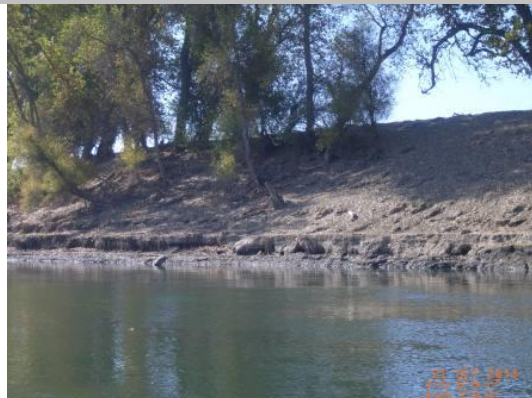
Photo 1 of 1 : FA_2019_NA0016_435_95_20190829_00033.jpg

LM Start	42.90	Rating **	A/W	Issue No.	95
LM End	43.09	Issue Type +	Ma	Location *	WS
Category	Supplemental			GPS Latitude/Longitude	
				Start	End
Item	2017 USACE Erosion Survey			39.172501 °	39.174949 °
				-121.939053 °	-121.940737 °
DWR ID	DWR_NA0016_01_f _ 2018_95				
Comment Code					
Inspector Comment					
2017 Site ID: SAC 136.6 R					
Status: Eroding					
2017 Field Notes: New erosion observed along the entire bank slope.					
Site History: 2010 - Lower portion of 136.7 that did not extend far enough. Abrupt transition from upstream site. 2012 - Site extended upstream, minor new erosion. 2013 - Minor new erosion at the toe.					
New tree popout. Downstream limit extended. 2016 - Site continues to worsen, fresh erosion at toe.

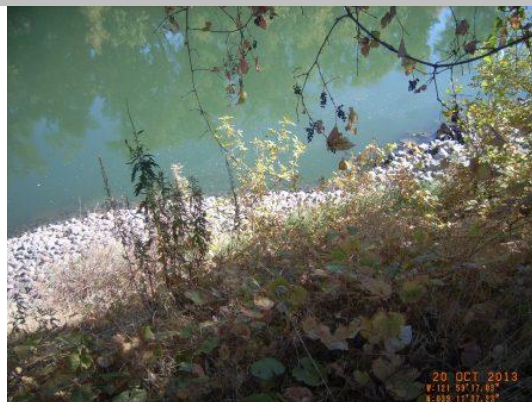
Photo 1 of 1 : FA_2019_NA0016_435_97_20190829_00035.jpg

LM Start	47.62	Rating **	A/W	Issue No.	97
LM End	47.77	Issue Type +	Ma	Location *	WS
Category	Supplemental			GPS Latitude/Longitude	
				Start	End
Item	2017 USACE Erosion Survey			39.193769 °	39.195595 °
				-121.987901 °	-121.988621 °
DWR ID	DWR_NA0016_01_f_2018_97				
Comment Code					
Inspector Comment					
2017 Site ID: SAC 141.5 R					
Status: Eroding					
2017 Field Notes: No observed change.					
Site History: 2010 - Old cobble site starting to unravel at toe. 2011 - Cobbles continue to unravel. 2013 - Site extended downstream to revetment.

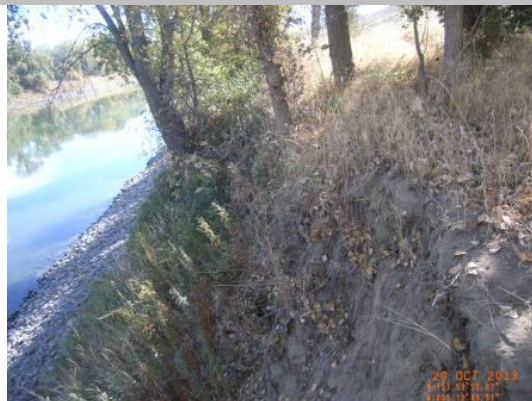
Photo 1 of 1 : FA_2019_NA0016_435_105_20190829_00039.jpg

LM Start	49.46	Rating **	A/W	Issue No.	105
LM End	49.57	Issue Type +	Ma	Location *	WS
Category	Supplemental			GPS Latitude/Longitude	
				Start	End
Item	2017 USACE Erosion Survey			39.213608 °	39.213869 °
				-121.997543 °	-121.999641 °
DWR ID	DWR_NA0016_01_f_2018_105				
Comment Code					
Inspector Comment					
2017 Site ID: SAC 143.5 R					
Status: Eroding					
2017 Field Notes: New erosion along lower slope.					
Site History: 2011 - Multiple scallops, one tree pop out. Old cobble site starting to unravel at midbank. 2012 - Mid bank slumping continues to worsen but cobble at the toe appears stable.
